Summary of Marine Safety Reports 2015

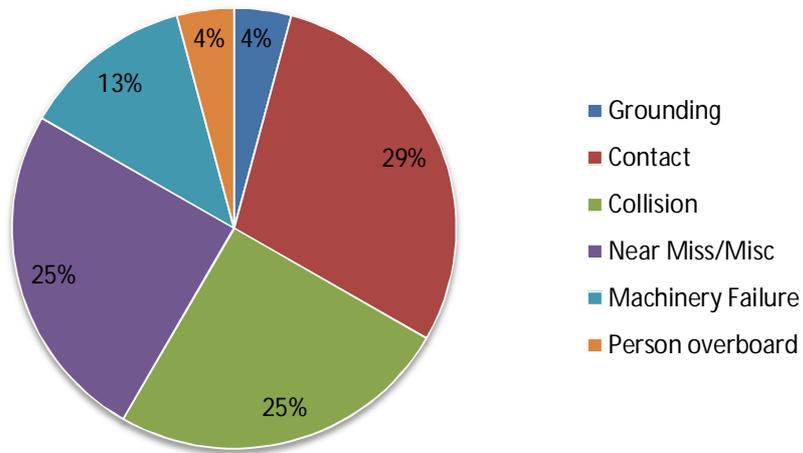
Figure 1, Incident Types to December 2015

Incident Type	Count of Incidents
1 Collision	6
2 Contact	7
3 Grounding	1
4 Near miss or misc	6
7 Person Overboard	1
9 Machinery Failure	3
Total	24

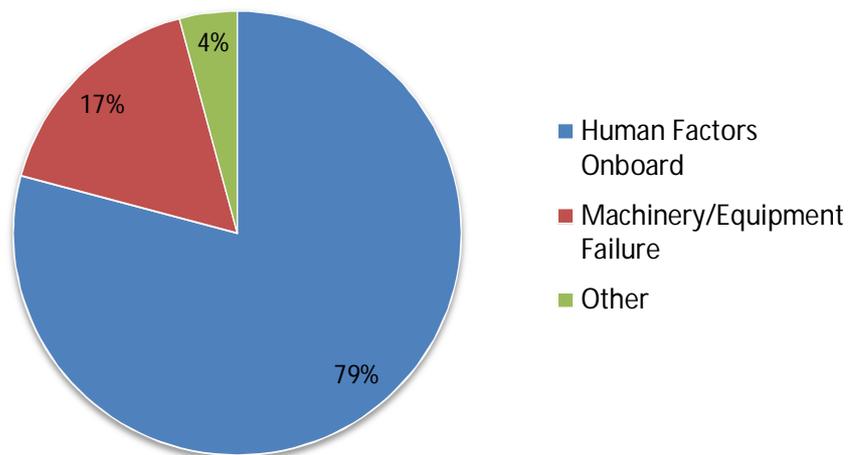
Figure 2, Incident Causes to December 2015

Incident Cause	Count of Incidents
Human factors onboard	19
Machinery/Equipment failure	4
Other	1
Total	12

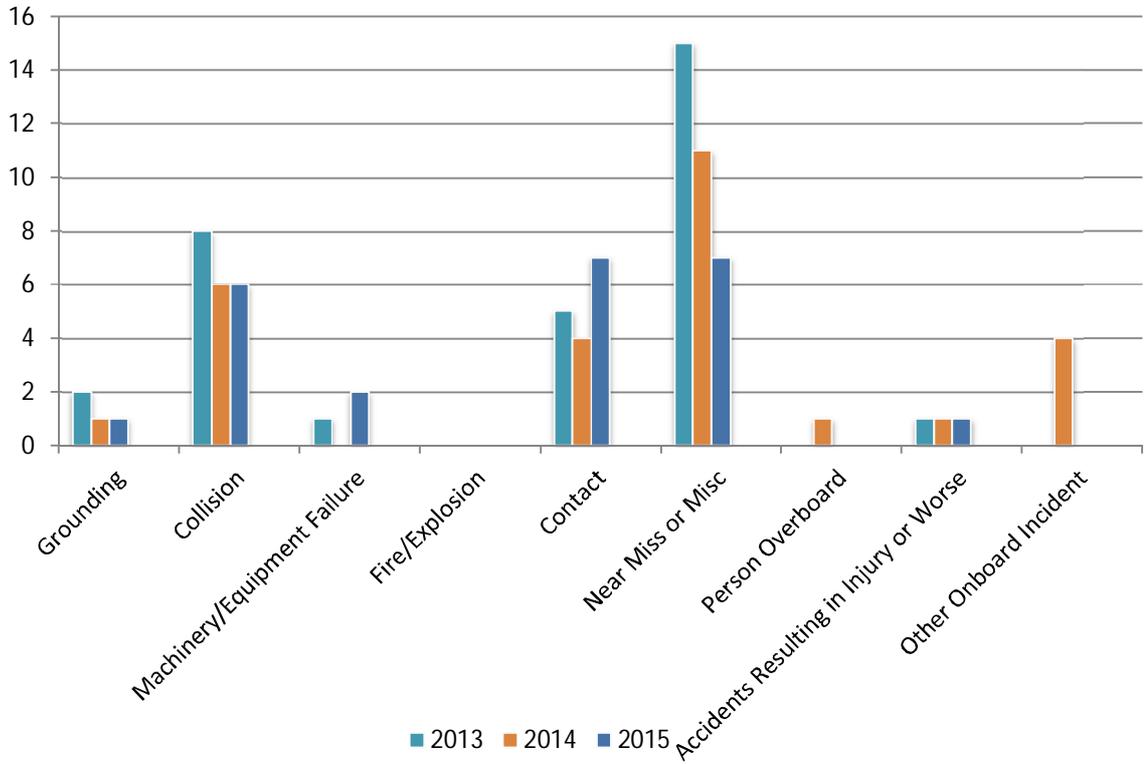
Figure 3, Incident Types since 2013

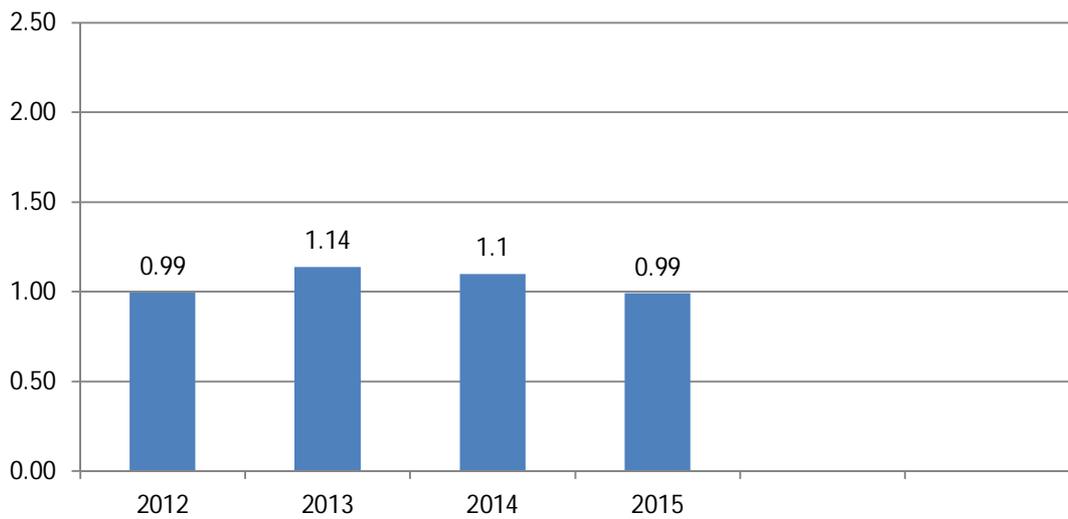
Figure 4, Incidents per 1000 Vessel Movements since 2012

This equates to 0.99 incidents per 1000 vessel movements.

2. Total movements is the sum of arrivals, departures, shifts and non-statistical movements between the last board meeting in the previous reported year and the last Board meeting of the reporting year. In 2015 this amounted to 24102 movements.
